Manhole Inspection Summary

Manhole # S43M__019MH

Insp Date: **6/5/08 12:14 PM**

Location Address: **across 801 caroline st**

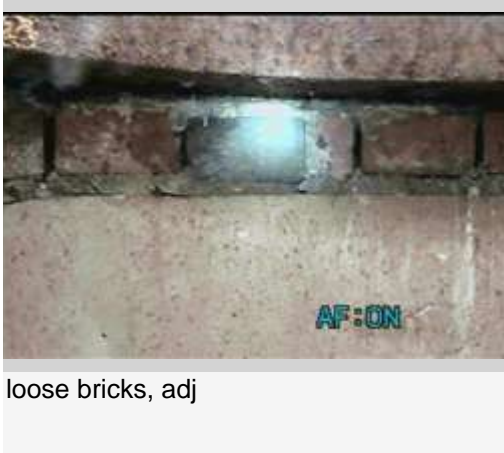
Defect 1

Condition: ☐ Sound ☐ Cracked ☐ Root Intrusion ☒ **Loose Brick** ☐ Deteriorated

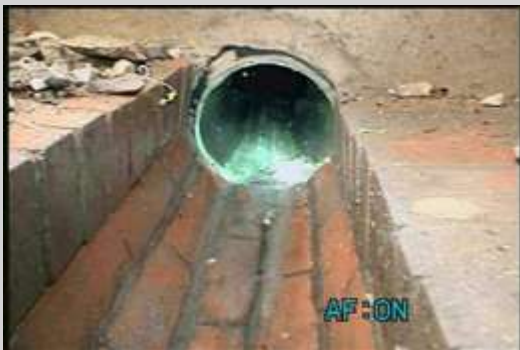
12 O'Clock Outflow

8 in. Circular Gravity Sewer
Pipe Out @ 12 OClock

Pipe Height: **0** (in.) Direct
Pipe Material: **Clay** ☐ Pipe Lined
Invert Depth: **7.69** (ft.) Flow Characteristics: **Fast**
Deposits: ☒ None ☐ Mud ☐ Sludge ☐ Debris ☐ Grease
Silt Depth: **0** (in.) Deposits Extent:
Infiltration: **None** Pipe Seal Cond: **Unknown**

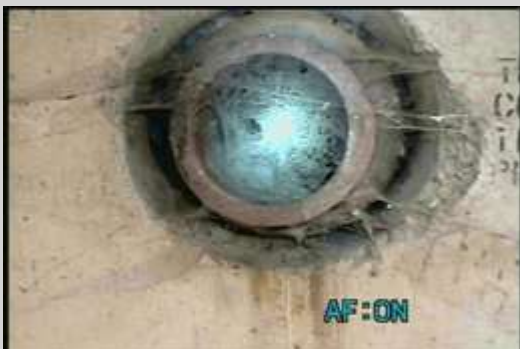
6 O'Clock Inflow

missing mortar at penetration

Pipe Height: **0** (in.) Direct
Pipe Material: **Clay** ☐ Pipe Lined
Invert Depth: **3.81** (ft.) Flow Characteristics: **Fast**
Deposits: ☒ None ☐ Mud ☐ Sludge ☐ Debris ☐ Grease
Silt Depth: **0** (in.) Deposits Extent:
Infiltration: **None** Pipe Seal Cond: **Unknown**

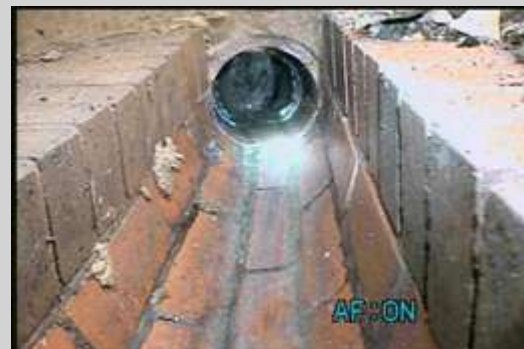
Drop In @ 6 OClock

Drop: **Inside** **Direct**
Angled: Reading: **0.00** (ft.)
Inv Depth: **7.49** (ft.)

Drop Condition: **Open**

Connects To: **Dead End**
